Revegetation, Soil Loss, and Management in the Talakhaya Watershed

Prepared by Malcolm Johnson, NOAA
Coral Reef Management Fellow

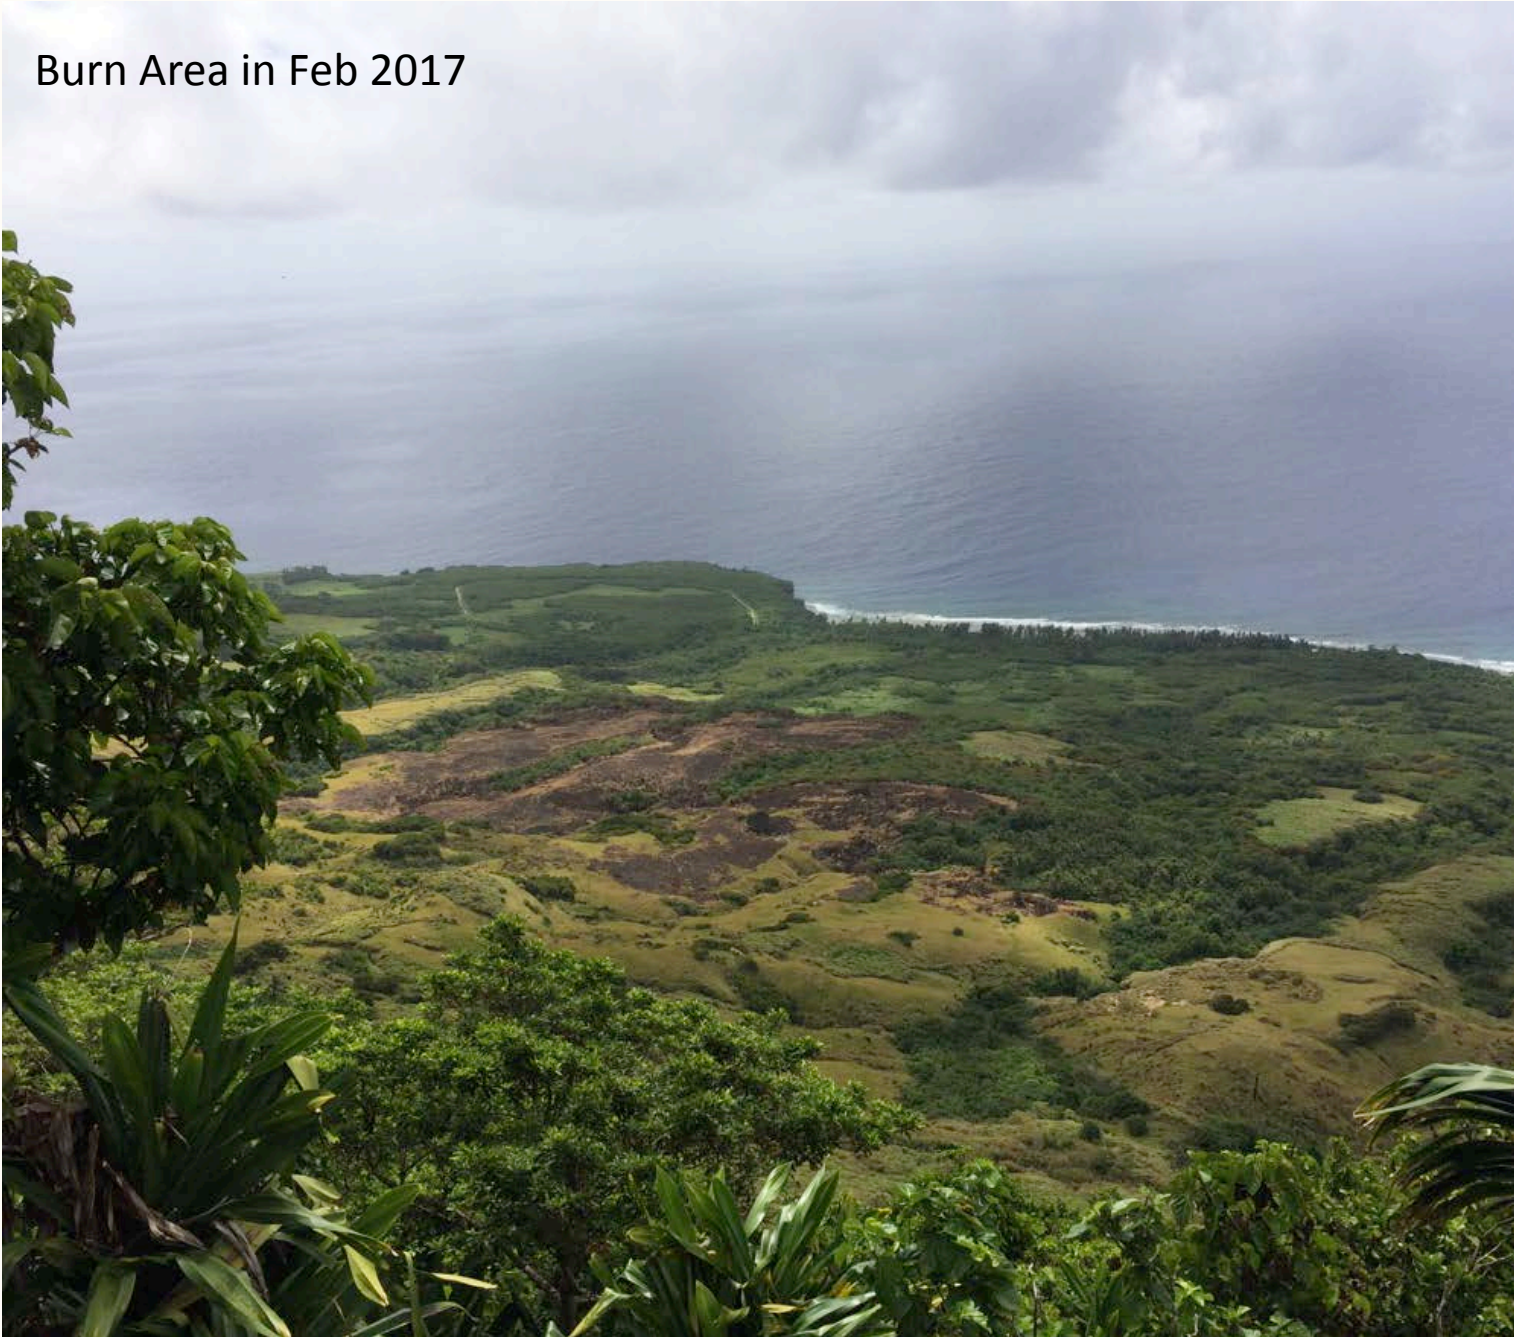
Burn Area in Feb 2017

The Sabana/
Talakhaya
watershed is
approximately
4,900 acres and
contains the
island's only
streams and
wetlands within
a riparian
network

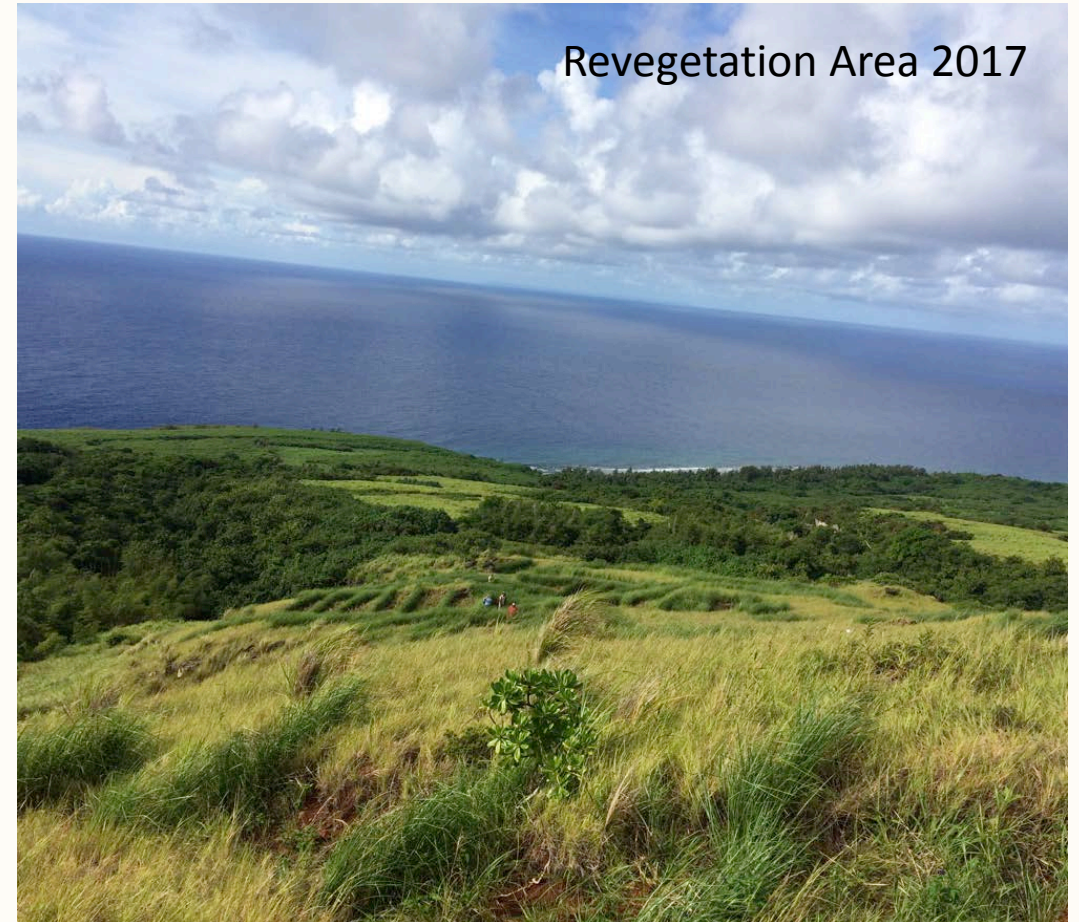
Revegetation 2017

- Planting in the control area
- Higher numbers than previous years
- 2017 Planting numbers:
 - Vetiver grass.....37,417
 - Bahia grass.....3,491
 - Acacia confusa.....1,480
- Qualitative data vs. quantitative

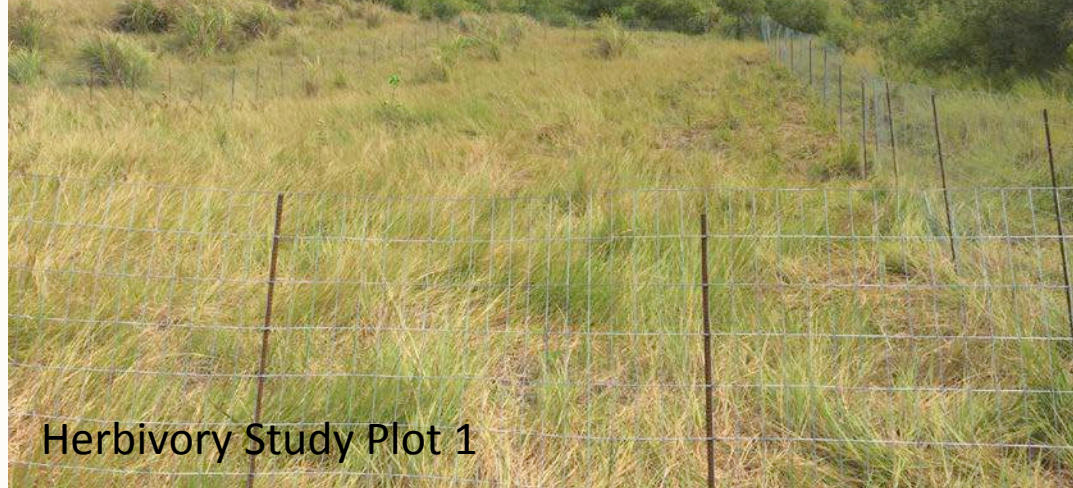
Herbivory Study Plot 1

- Challenges for the future:
 - Dealing with deer (herbivory study)
 - “Real hunters don’t burn”
 - Targeting barren areas
 - Transitioning from grasses to trees
 - Hard to reach locations
 - Funding fears

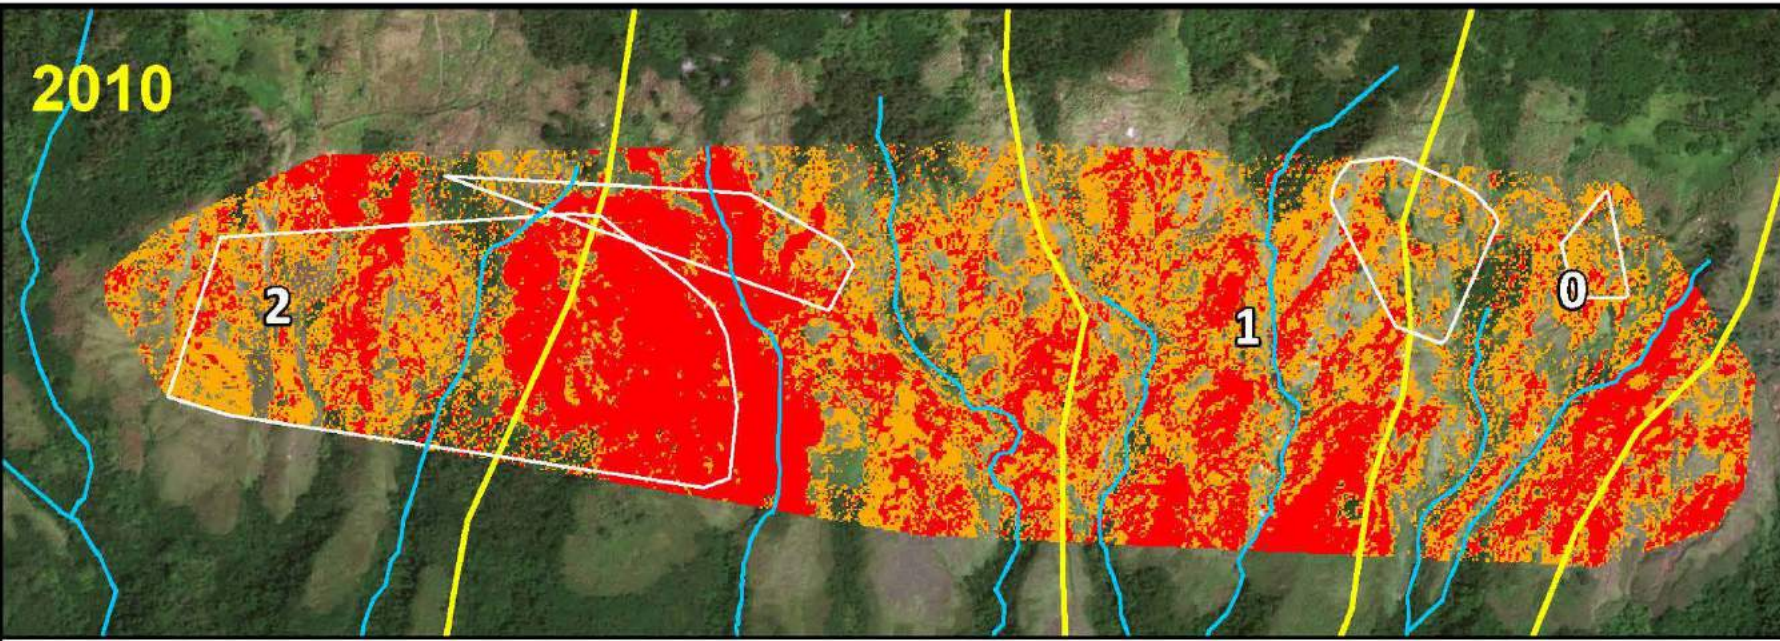
**Figure 5. Barrren Areas within
2010-2013 Replanting Zones**

2010

2014

Revegetation is reducing barren areas, however the challenges of mapping and methodology make it difficult to make soil loss conclusions
